Inspection Report

123 Inspection Street, Inspection Town, VICTORIA, 3000

Report/Agreement #	210823040952109
Inspection Date:	27 Feb 2021
Inspection Time:	11:45 am

For complete and accurate information please refer to the attached complete visual timber pest report, provided in accord with AS 4349.3-2010

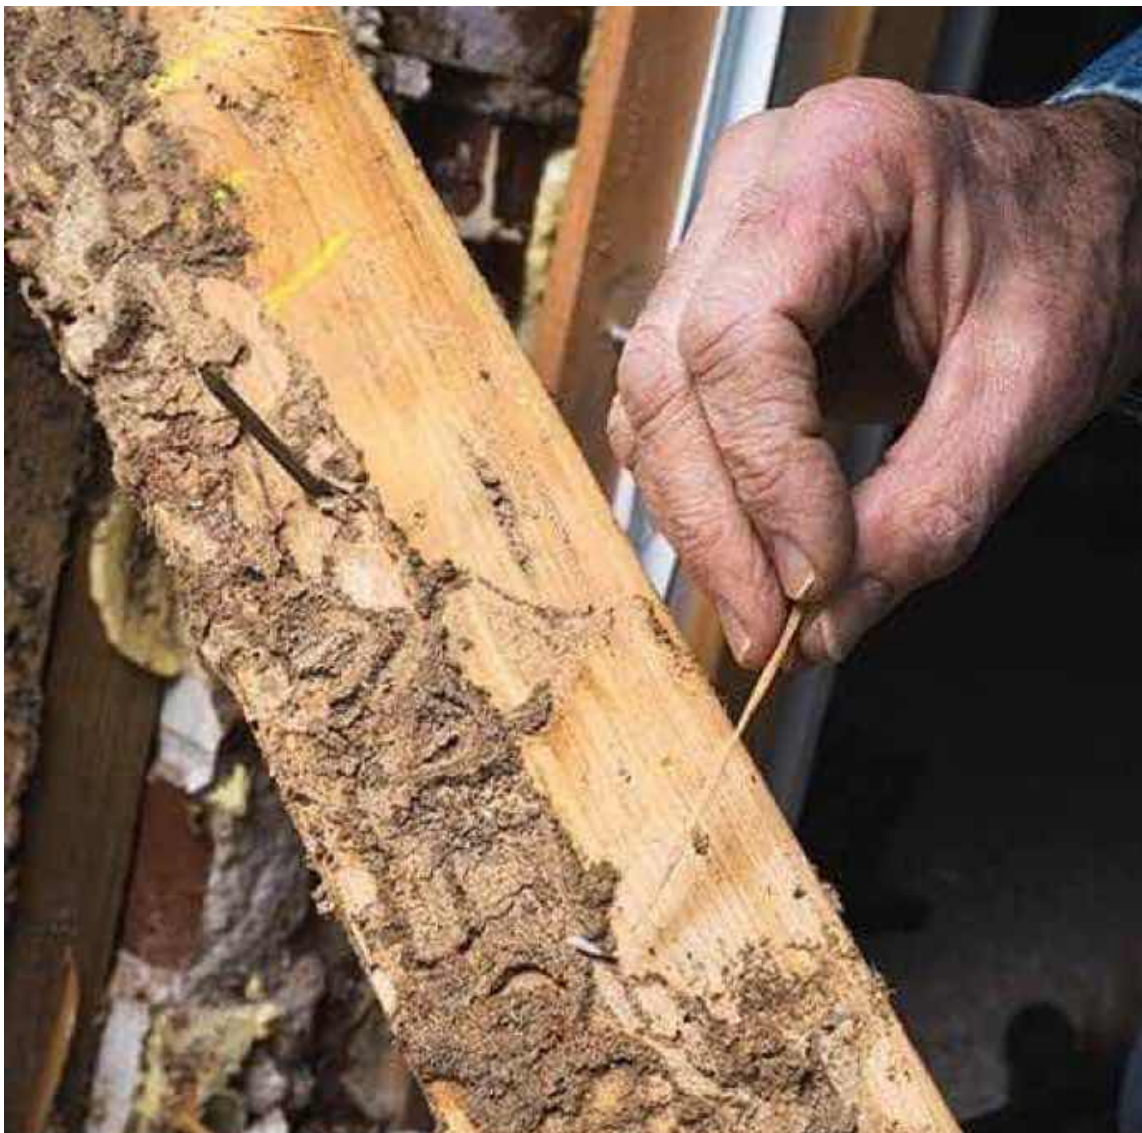
Roof frame timbers.

Roof framing timber

Widespread damage.

Yes, the safety hazard due to timber pest damage is considered to be major.

A management program in accord with AS 3660 to protect against subterranean termites is considered to be essential.

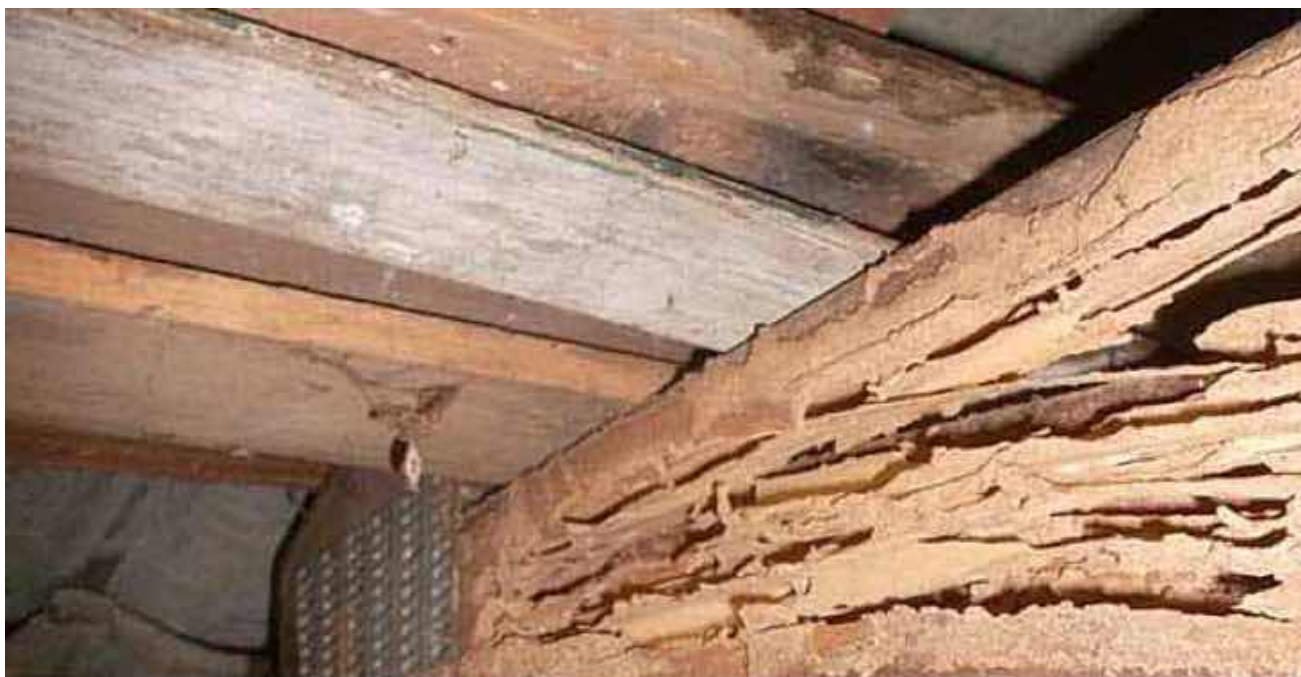
Sub floor timbers.

Subfloor Joist

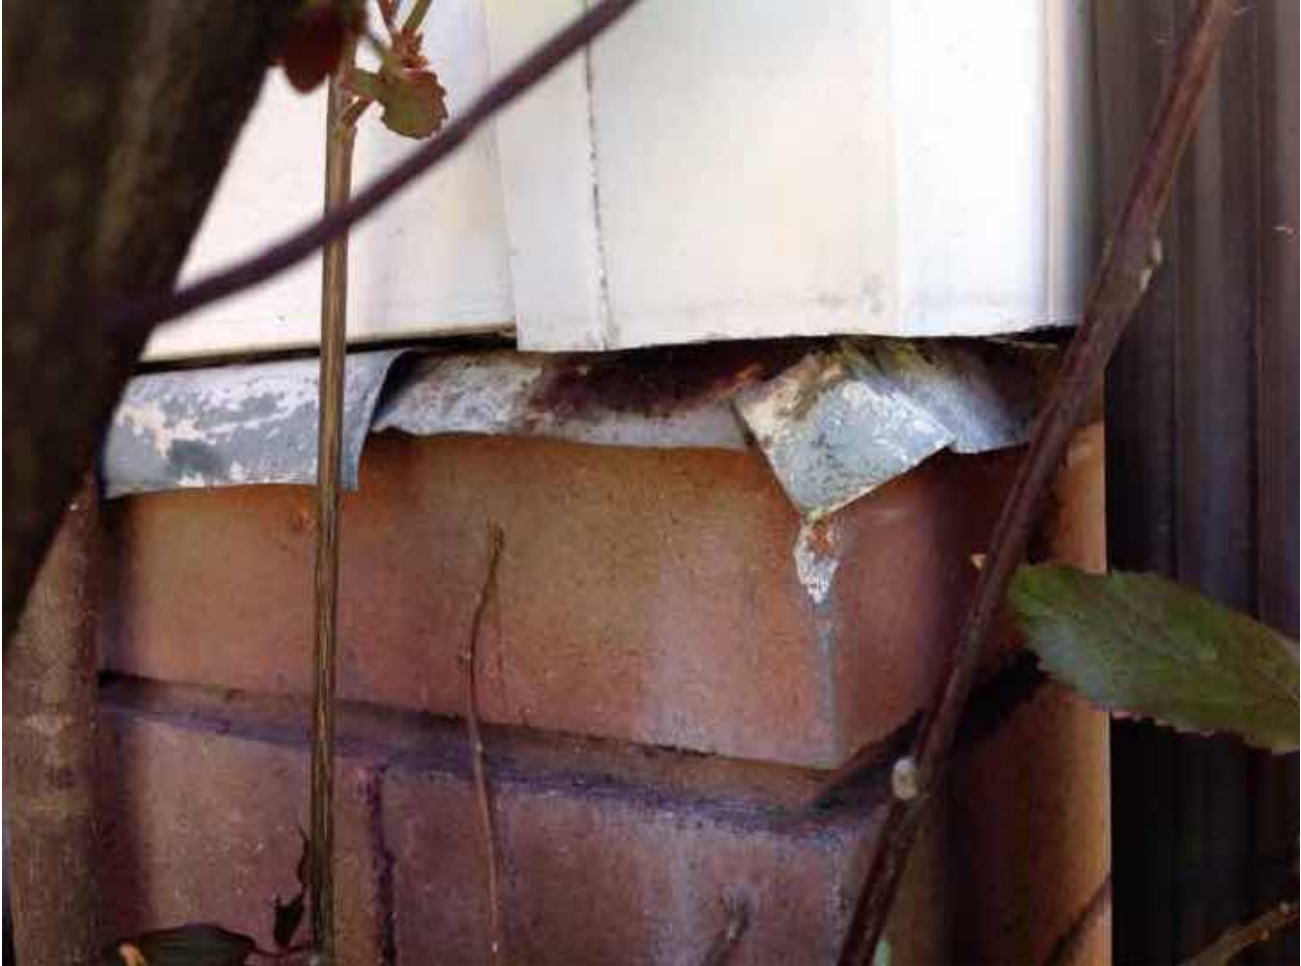
The termite shields (ant caps) are inadequate. Consult an appropriate trade for a scope of works and cost of repairs for the issue prior to contracts becoming binding.
