# Inspection Report

## Inspection Address

**100 Inspection Street, Inspection Town, NSW, 2000**

### Pest And Building Inspection

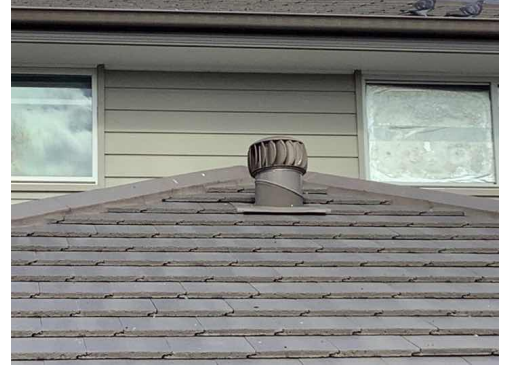
Due to height restrictions only the lower roof only was inspected and of the visible and accessible areas, the general condition of the roof is in serviceable condition for the age.

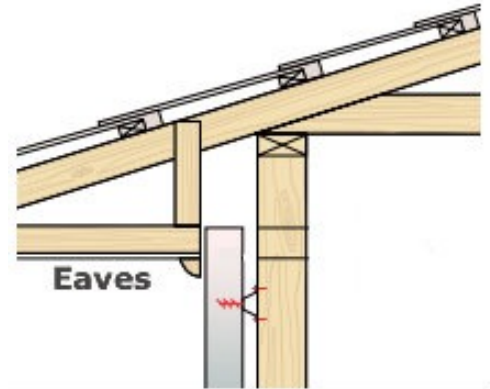
The soffit lining (eaves) are in a serviceable condition with no notable defects.

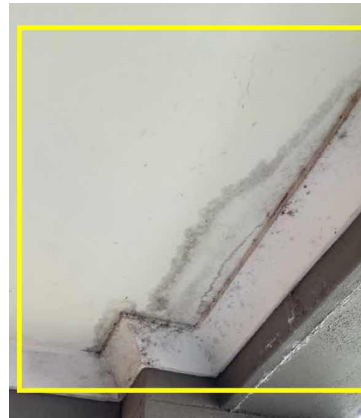
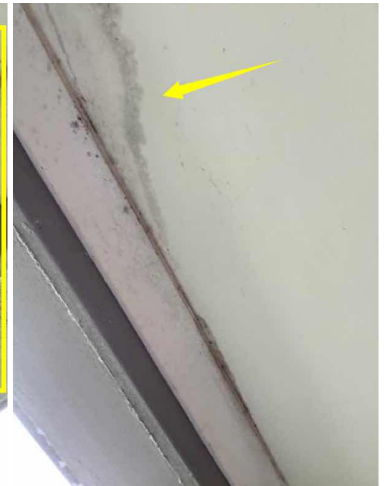
Ceiling stains - Moisture readings obtained. Possibly still active leaking from balcony above..  
 Recommendations: A qualified tiker/waterproofing specialist should be engaged for advice and recommendations. It is strongly advised to have all water damaged plaster replaced by a qualified plasterer due to potential detachment or collapse.

Clear evidence of leaks

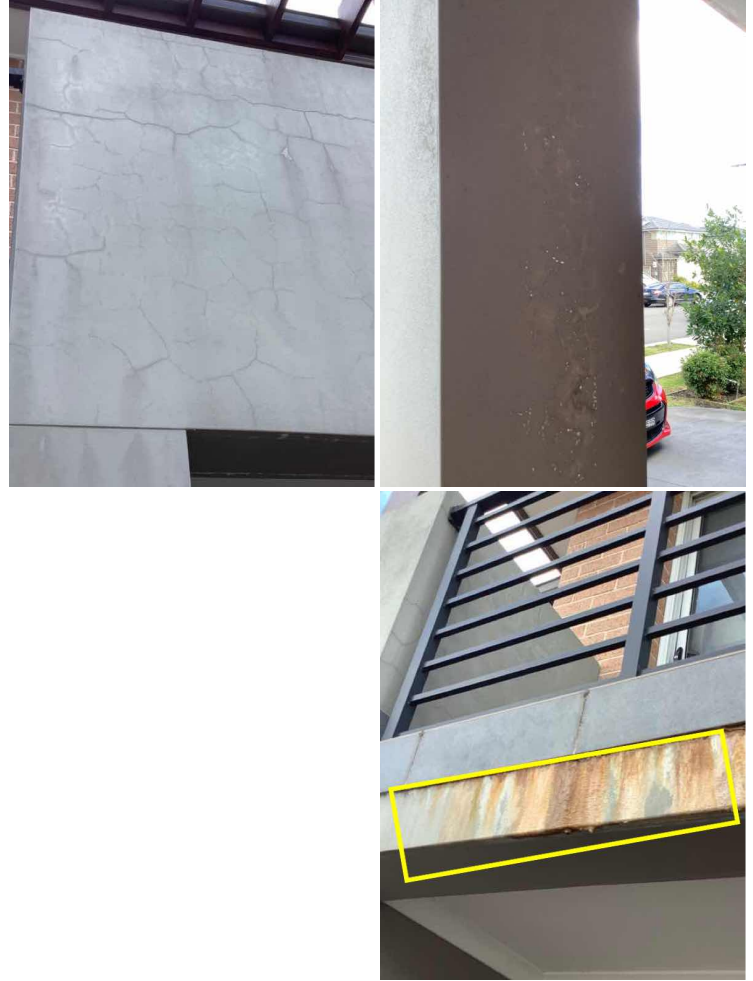
High levels of moisture detected.

Render bubble/flake deterioration on wall visible possible rising issue (See rising Damp section) -

Recommendations: Engage a renderer for advice and recommendations.

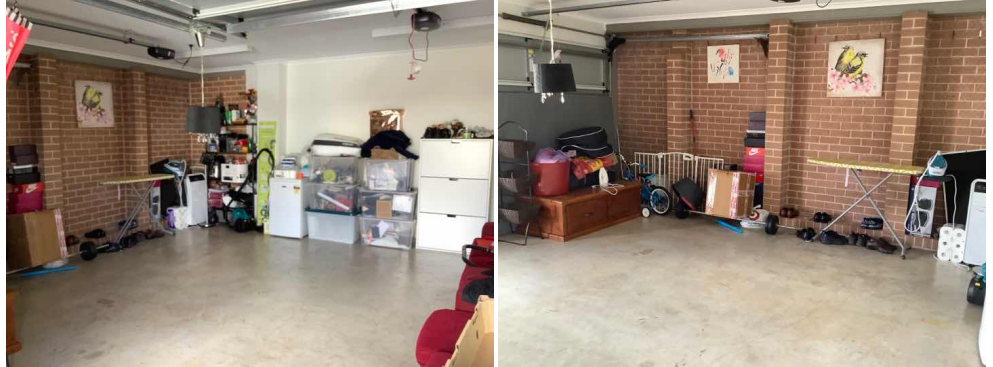
From the visible and accessible areas, the garage appears to be in a serviceable condition for the age of the property with no notable structural defects sighted.

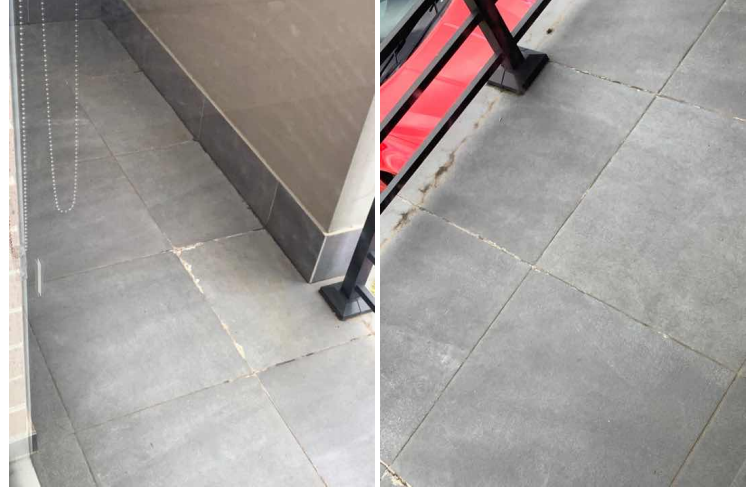
Leaching (Efflorescence) observed. This is a result of mineral salts and crystal formations leaching out from the sand and cement bed below the tiles and seeps via the grout joints. Contact a qualified tiler for further advice and recommendations.

Leaking has occurred through flooring to the underside. I suspect this is a waterproofing issue. Tiles may need to be removed to waterproof same. A qualified contractor should be engaged for advice and recommendations.

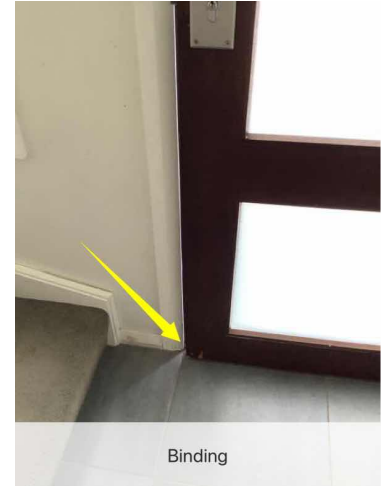
Binding entry door - Doors that bind on the frame can relate to some differential settlement, frame movement, age, expansion, shrinkage or poor hanging. A qualified carpenter should be engaged for repairs.

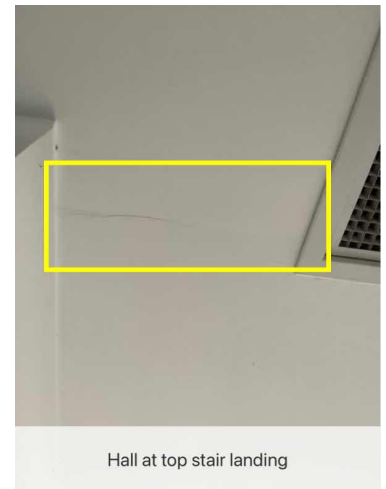
Hall at top stair landing

Settlement Cracks Noted. These are typical and generally patch and paint will suffice, however monitoring these cracks is advised for 12 months and if they become worse, further investigation by a suitably qualified professional is advised.

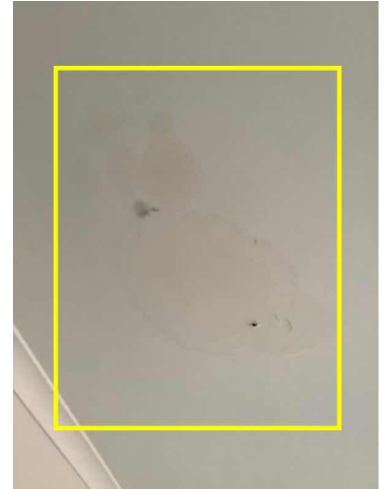
Ceiling stains with damage due to leak - No moisture readings obtained. These may have been repaired however you will need to monitor after a prolonged period of rainfall. If leaking persists, a qualified plumber should be engaged for advice and recommendations. All water damaged plaster should be replaced.

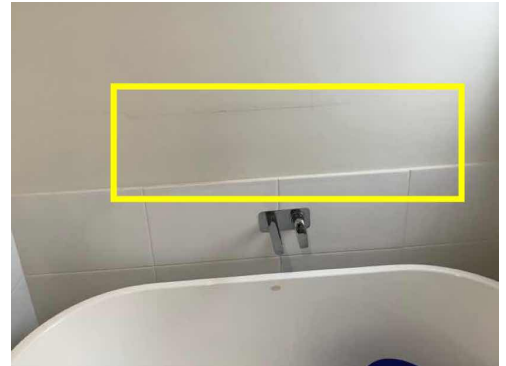
Settlement Cracks Noted . These are typical and generally patch and paint will suffice, however Monitoring these cracks advised for 12 months and if become wider or longer, you will need to contact a structural engineers to assess.

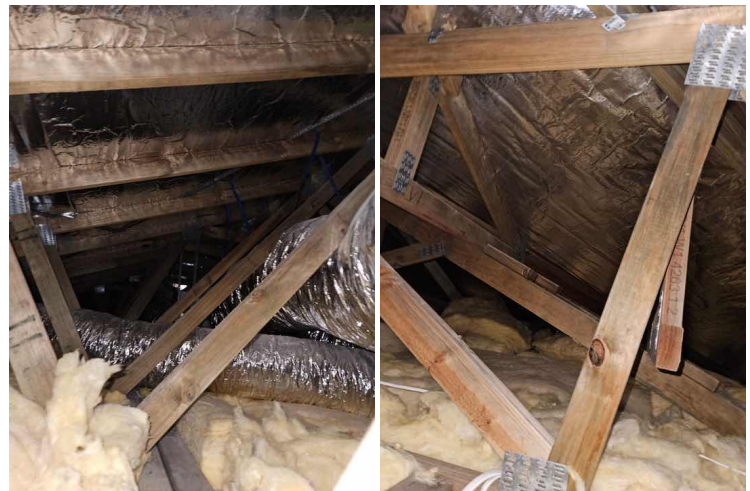
Visible sections of the roof void is in a serviceable condition for age of this dwelling.
