# Inspection Report

**100 Inspection Street, Inspection Town, NSW, 2000**

### Pest And Building Inspection

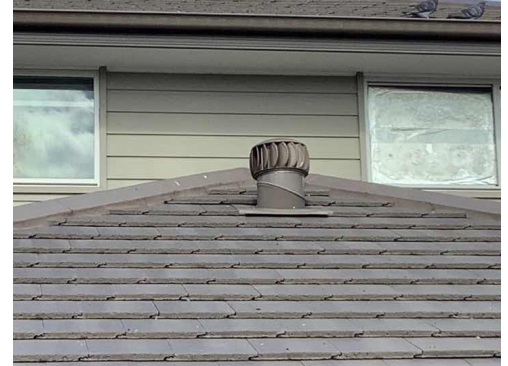
Due to height restrictions only the lower roof only was inspected and of the visible and accessible areas, the general condition of the roof is in serviceable condition for the age.

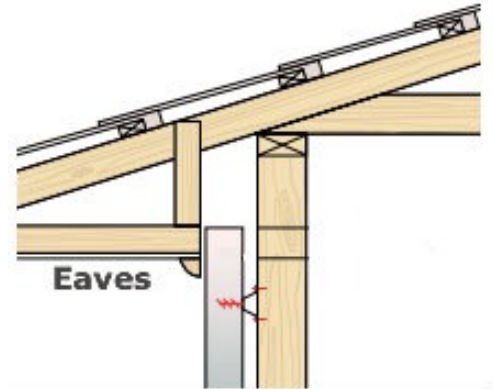
The soffit lining (eaves) are in a serviceable condition with no notable defects.

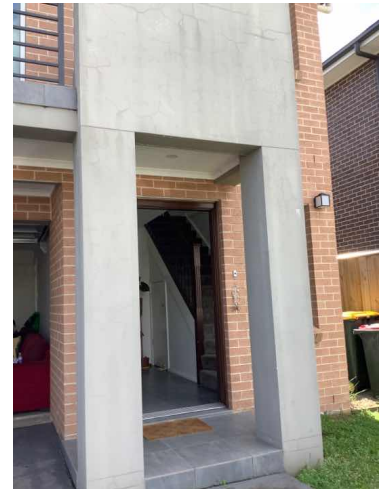
Defects exist to an area or component/s requiring assessment by a specialised field. Please read below for details.

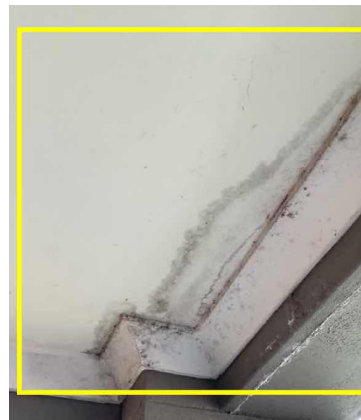
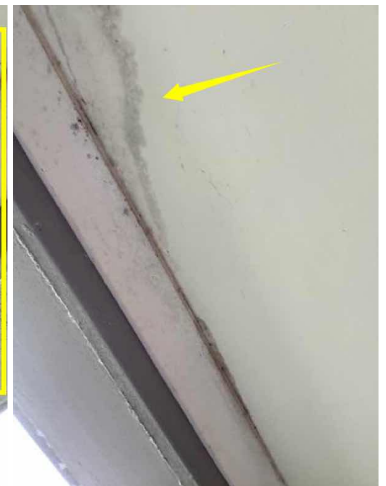
Ceiling stains - Moisture readings obtained. Possibly still active leaking from balcony above..  
 Recommendations: A qualified tiker/waterproofing specialist should be engaged for advice and recommendations. It is strongly advised to have all water damaged plaster replaced by a qualified plasterer due to potential detachment or collapse.

Clear evidence of leaks

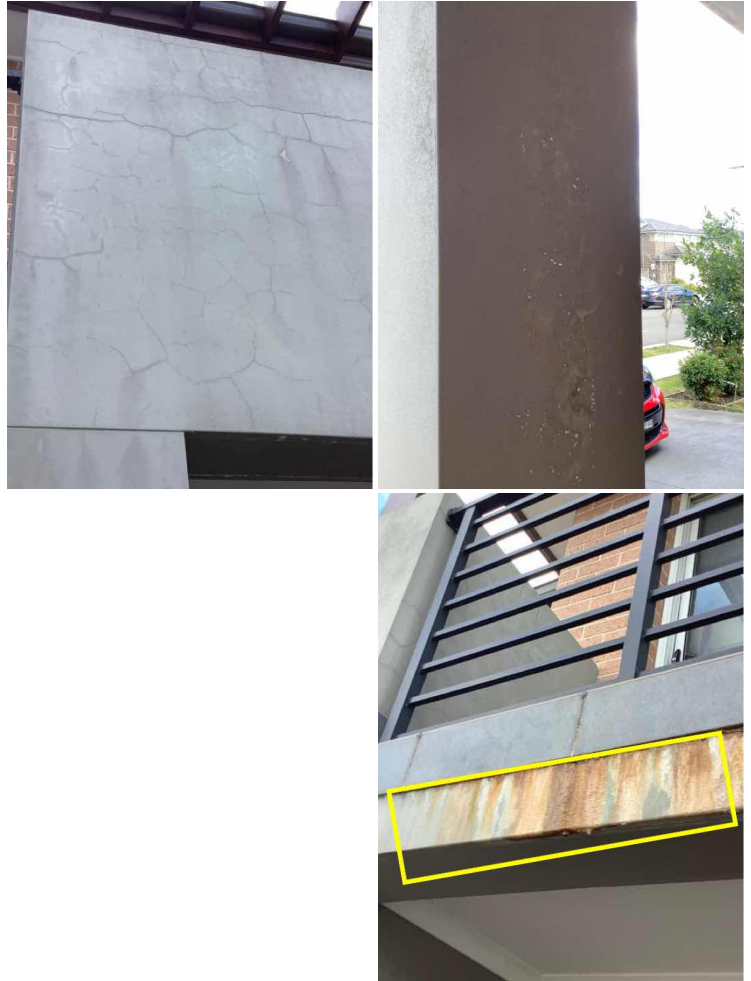
High levels of moisture detected.

Render bubble/flake deterioration on wall visible possible rising issue (See rising Damp section) -

Recommendations: Engage a renderer for advice and recommendations.

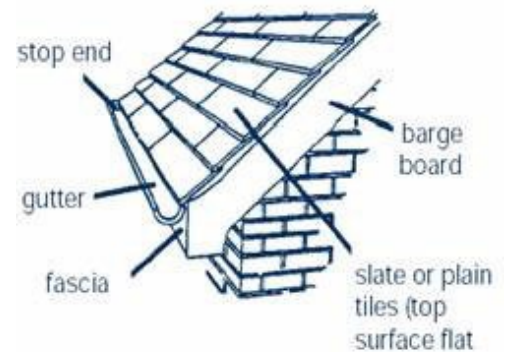
On visual inspection, the general condition of the fascia/barge boards is serviceable.

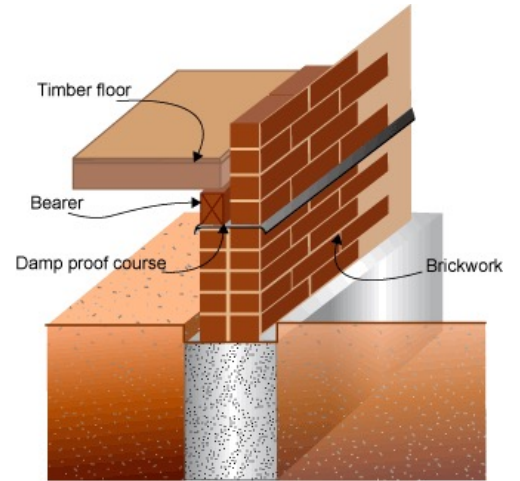
Of the visible and accessible areas, there was no visible evidence of excessive rising damp on the external walls at time of inspection.

A damp proof course (DPC) was noted.

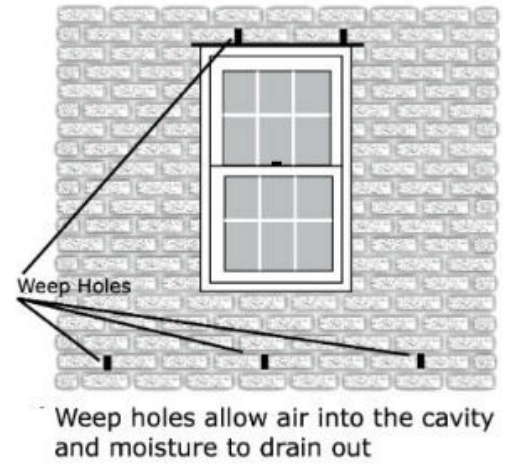
The weep holes are unobstructed .

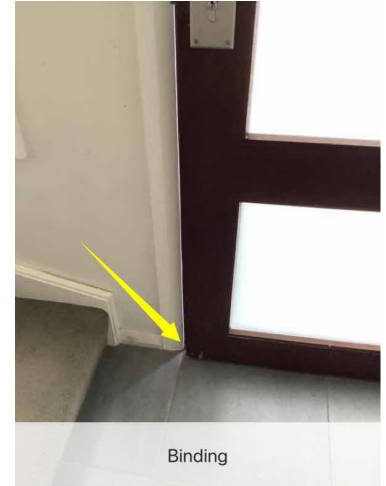
Binding entry door - Doors that bind on the frame can relate to some differential settlement, frame movement, age, expansion, shrinkage or poor hanging. A qualified carpenter should be engaged for repairs.

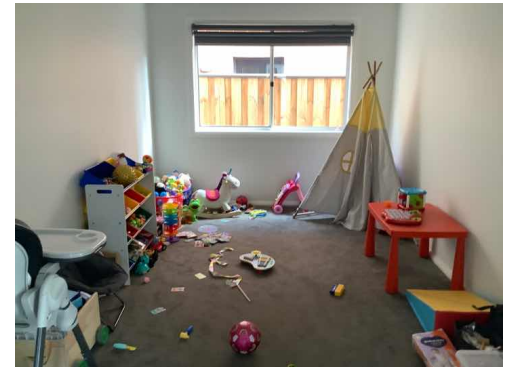
From the visible and accessible areas, this room appears to be in a serviceable condition for the age of the property with no notable structural defects sighted.

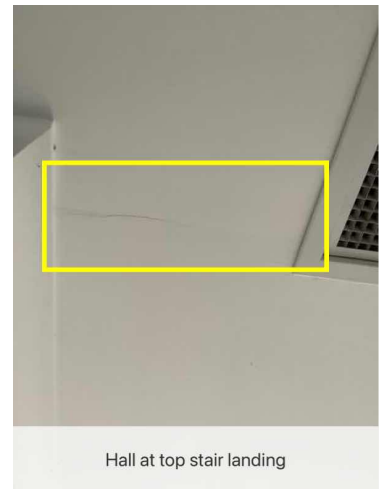
Hall at top stair landing

Settlement Cracks Noted. These are typical and generally patch and paint will suffice, however monitoring these cracks is advised for 12 months and if they become worse, further investigation by a suitably qualified professional is advised.

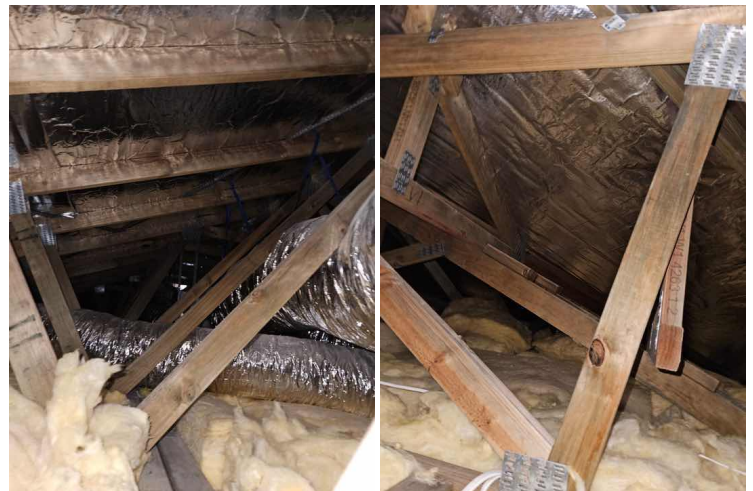
Visible sections of the roof void is in a serviceable condition for age of this dwelling.
