# Inspection Report

**100 Inspection Street, Inspection Town, NSW, 2000**

### Pest And Building Inspection

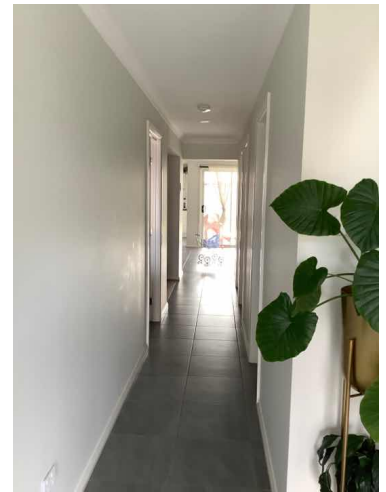
Settlement Cracks Noted. These are typical and generally patch and paint will suffice, however monitoring these cracks is advised for 12 months and if they become worse, further investigation by a suitably qualified professional is advised.

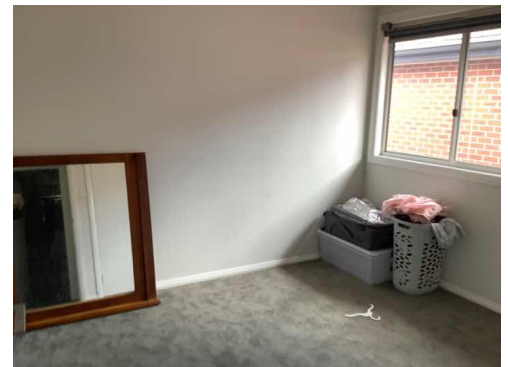
INTERIORS	Bedroom 2	Ceiling	Ceiling stains with damage due to leak - No moisture readings obtained. These may have been repaired however you will need to monitor after a prolonged period of rainfall. If leaking persists, a qualified plumber should be engaged for advice and recommendations. All water damaged plaster should be replaced.
BATHROOM(S)	Bathroom 1	Walls	Settlement Cracks Noted . These are typical and generally patch and paint will suffice, however Monitoring these cracks advised for 12 months and if become wider or longer, you will need to contact a structural engineers to assess.
CONCLUSION	Condition Of Inspected Structure	The Incidence of Minor Defects	The incidence of minor defects in this residential building as compared with similar buildings is considered TYPICAL

Ceiling stains with damage due to leak - No moisture readings obtained. These may have been repaired however you will need to monitor after a prolonged period of rainfall. If leaking persists, a qualified plumber should be engaged for advice and recommendations. All water damaged plaster should be replaced.

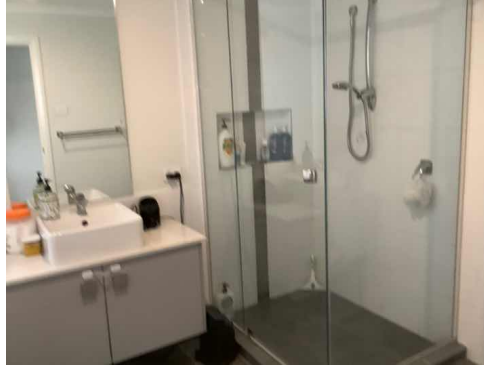
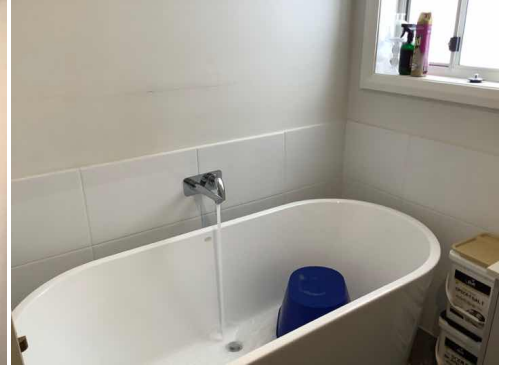
Settlement Cracks Noted . These are typical and generally patch and paint will suffice, however Monitoring these cracks advised for 12 months and if become wider or longer, you will need to contact a structural engineers to assess.

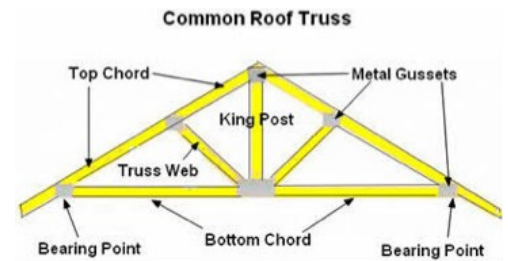
Visible sections of the roof void is in a serviceable condition for age of this dwelling.
