# Inspection Report

## Inspection Address

**100 Inspection Street, Inspection Town, NSW, 2000**

### Pest And Building Inspection

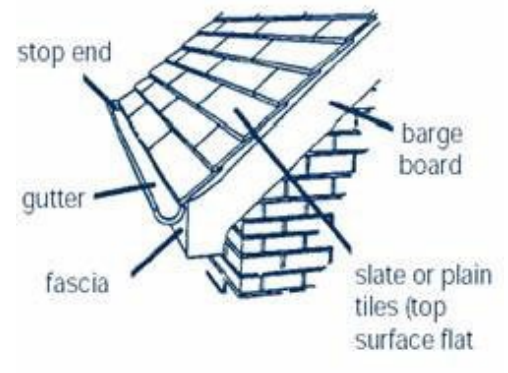
On visual inspection, the general condition of the fascia/barge boards is serviceable.

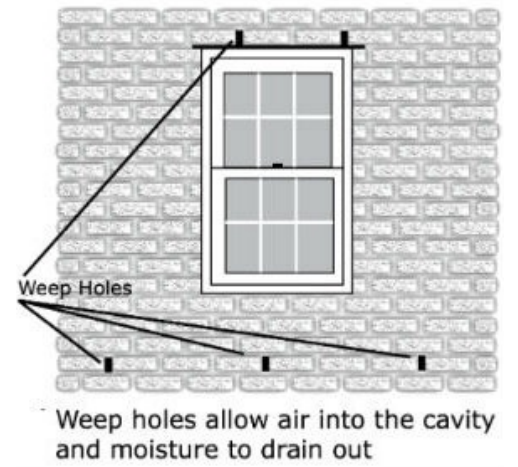
The weep holes are unobstructed .

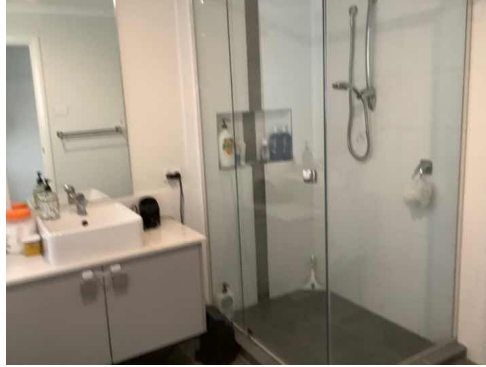
#### Walls

Settlement Cracks Noted . These are typical and generally patch and paint will suffice, however Monitoring these cracks advised for 12 months and if become wider or longer, you will need to contact a structural engineers to assess.

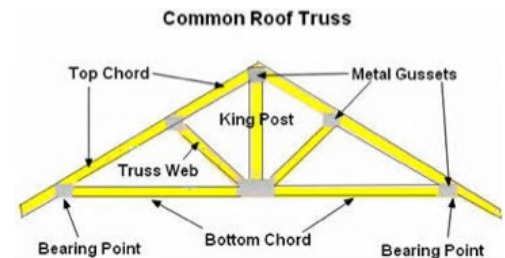
The roof frame is a truss timber frame.

Visible sections of the roof void is in a serviceable condition for age of this dwelling.
